Interim-Report CLEAN, Version May 2021

In-water Cleaning Trials and Permission Requirements

B. Watermann, LimnoMar, Hamburg,
Donna Lee Garrick, Die Senatorin für Klimaschutz, Umwelt, Mobilität,
Stadtentwicklung und Wohnungsbau Bremen,
Katja Pape, bremenports

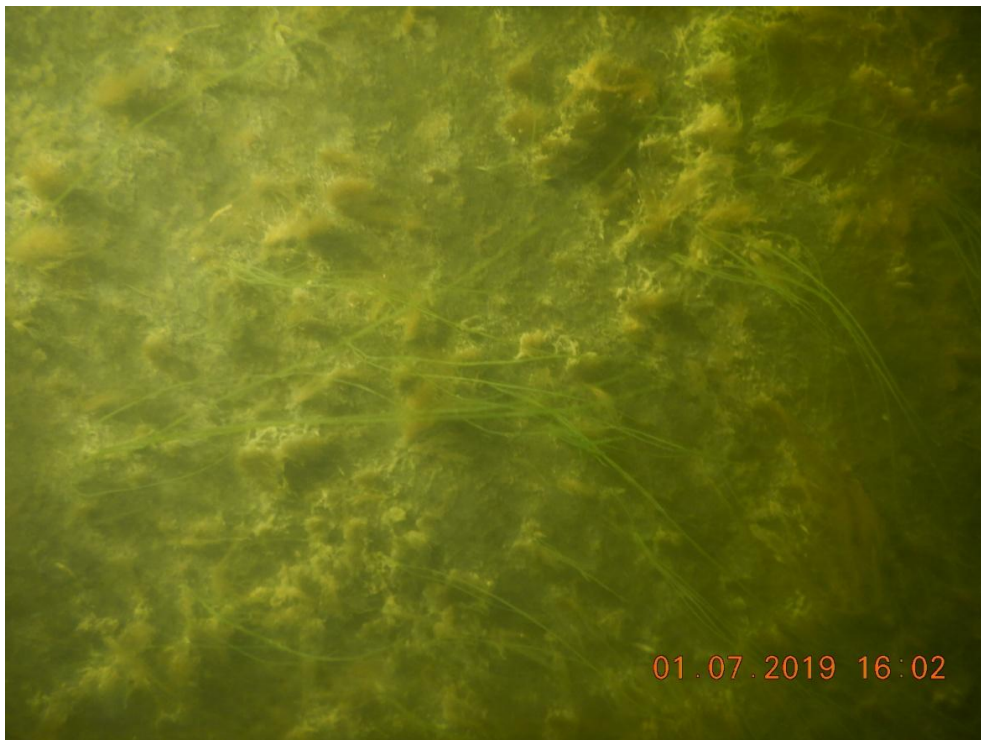
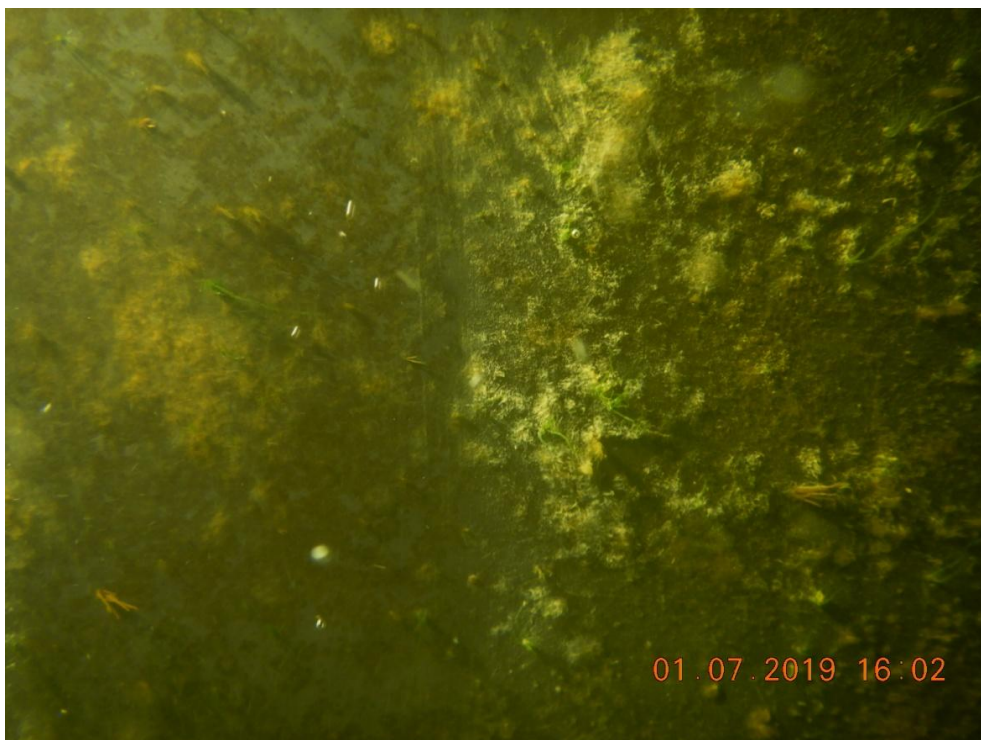
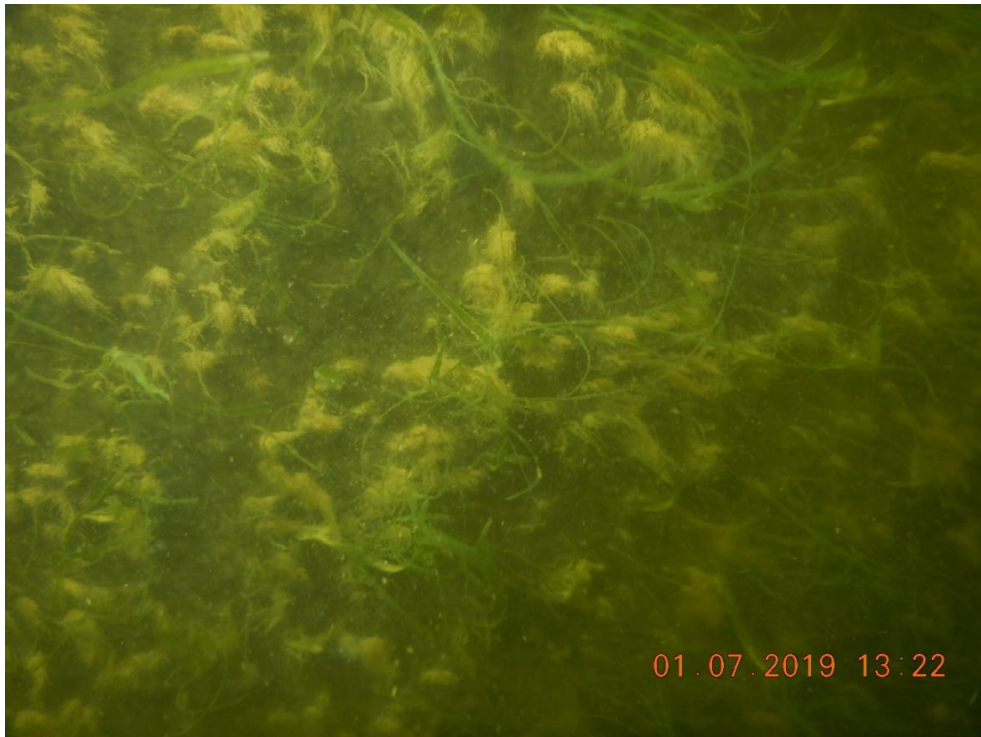
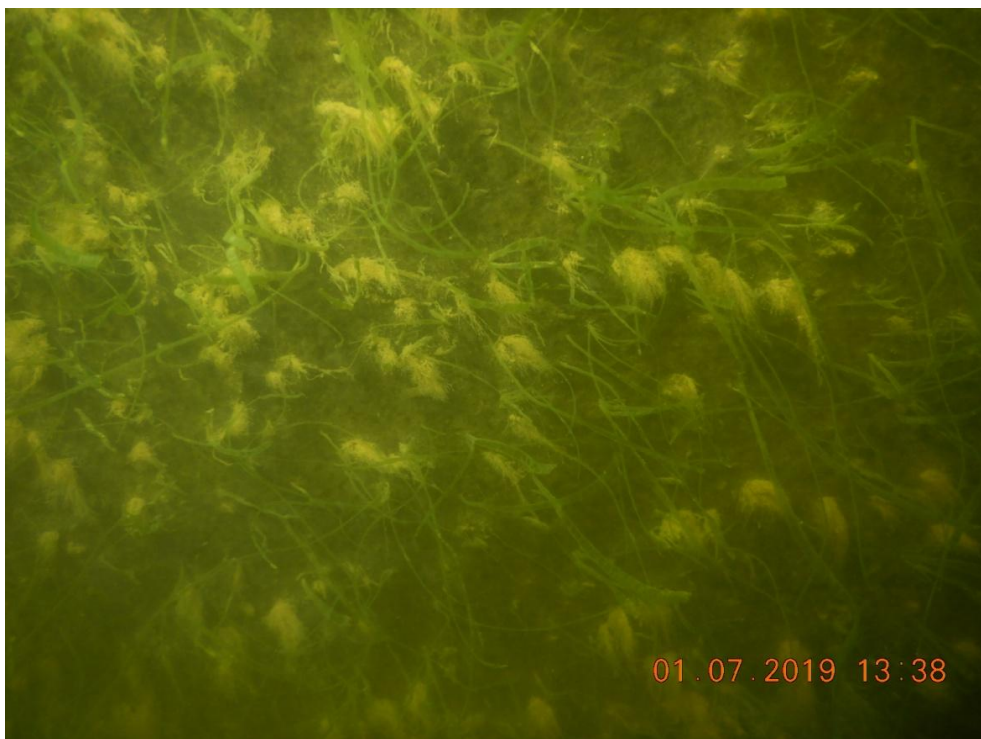
Fig. 6: Fouling community composed of biofilm and filamentous green algae, aft, „Polarstern“ at July 1, 2019 before the underwater cleaning by DG Diving

Fig. 7: Fouling community composed of biofilm and filamentous green algae, aft, „Polarstern“ at July 1, 2019 before the underwater cleaning by DG Diving

Fig. 8: Fouling community composed of biofilm and filamentous green algae, bow, ‚Polarstern‘ at July 1, 2019 before the underwater cleaning by DG Diving

Fig. 9: Fouling community composed of biofilm and filamentous green algae, bow, ‚Polarstern‘ at July 1, 2019 before the underwater cleaning by DG Diving

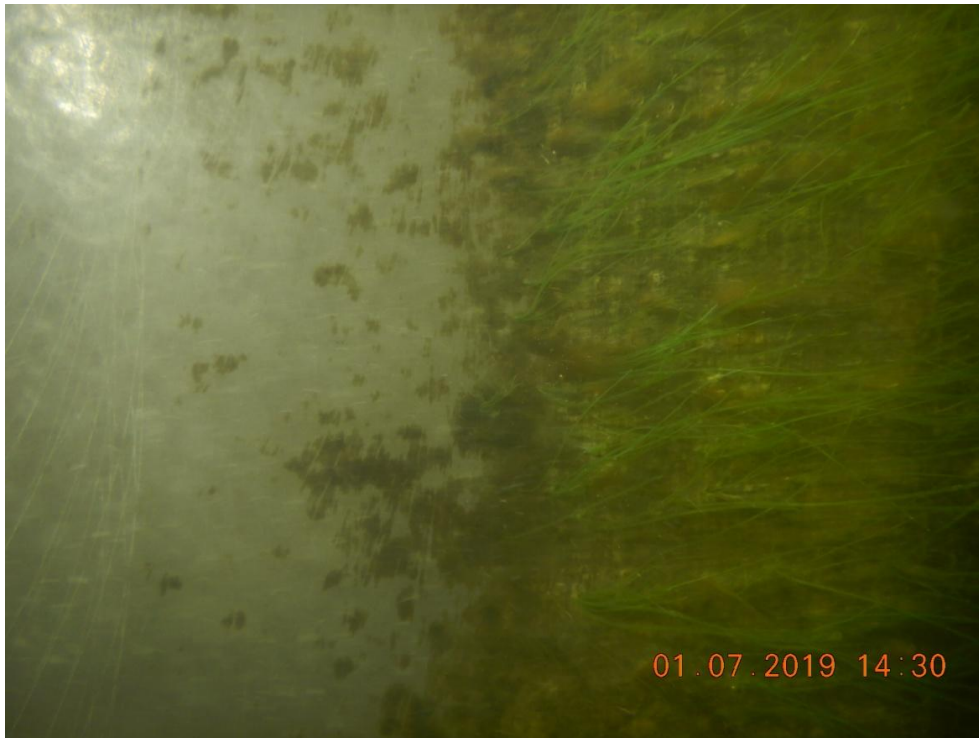
Fig. 10: Cleaned areas (left) with unremoved fouling (right) of dominantly green algae, bow area, 'Polarstern', July 1, 2019, DG Diving

The fouling could very easily be removed without remnants or damage of the paint (Fig. 10).

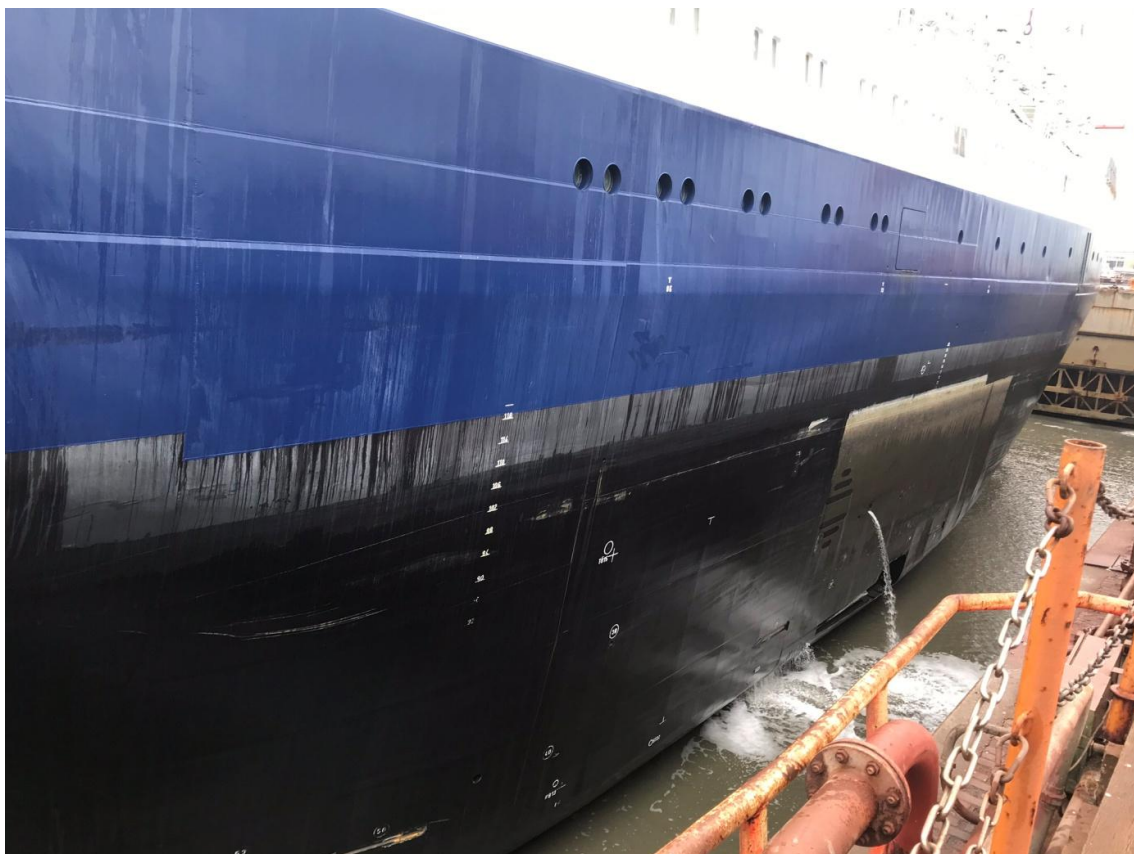
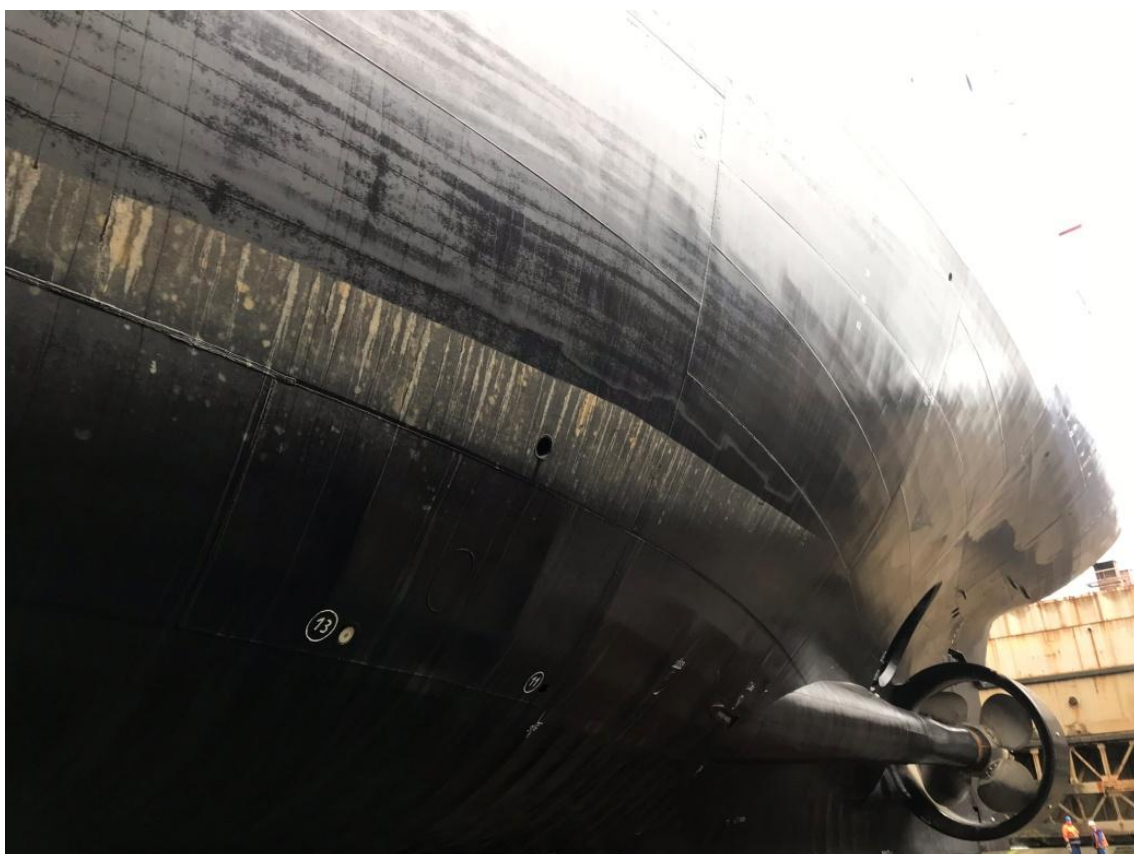
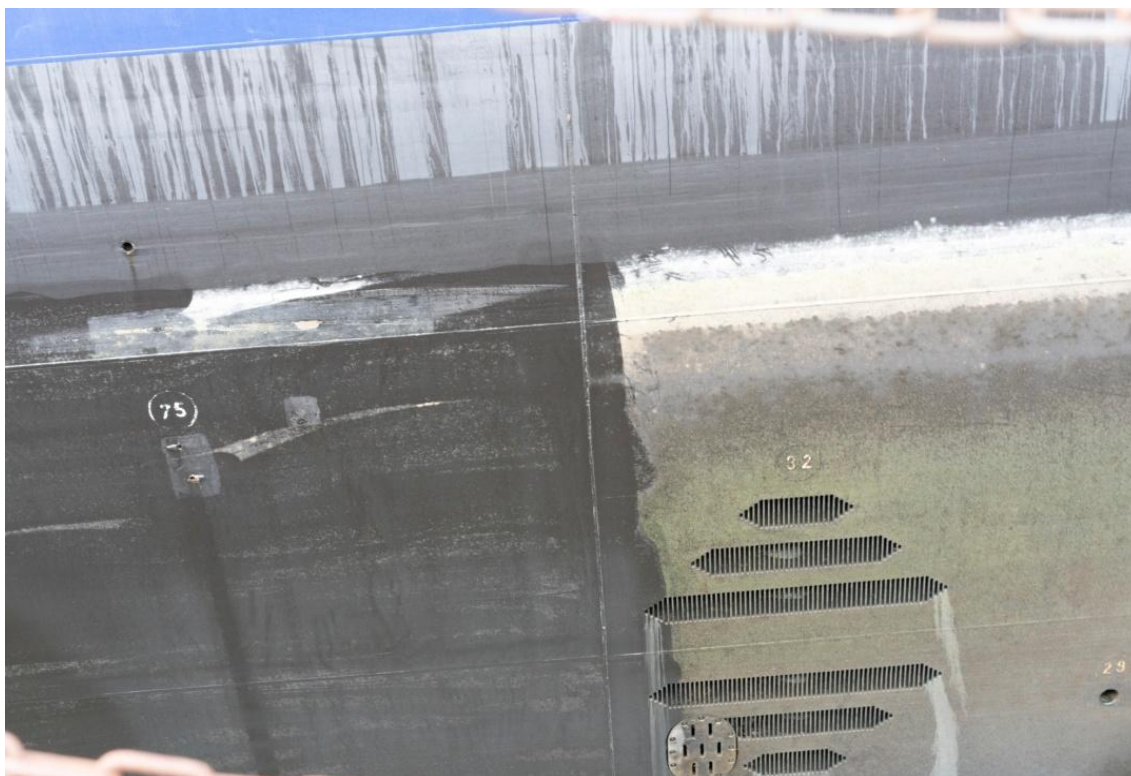
After dry-docking the hull was surveyed to check the efficacy of the cleaning action. It turned out that the fouling community had entirely been removed without any visible impact on the icebreaker coating. (Fig. 11 - 13).

Fig. 11: RV 'Polarstern' after underwater cleaning in the dry dock (Lloyd Dockyards, Bremerhaven), July 2019

Fig. 12: 'Polarstern' after cleaning in the dockyard, portside, (Lloyd Dockyards, Bremerhaven), July 2019

Fig. 13: RV ‚Polarstern‘ after cleaning in the dry dock, cleaned area left

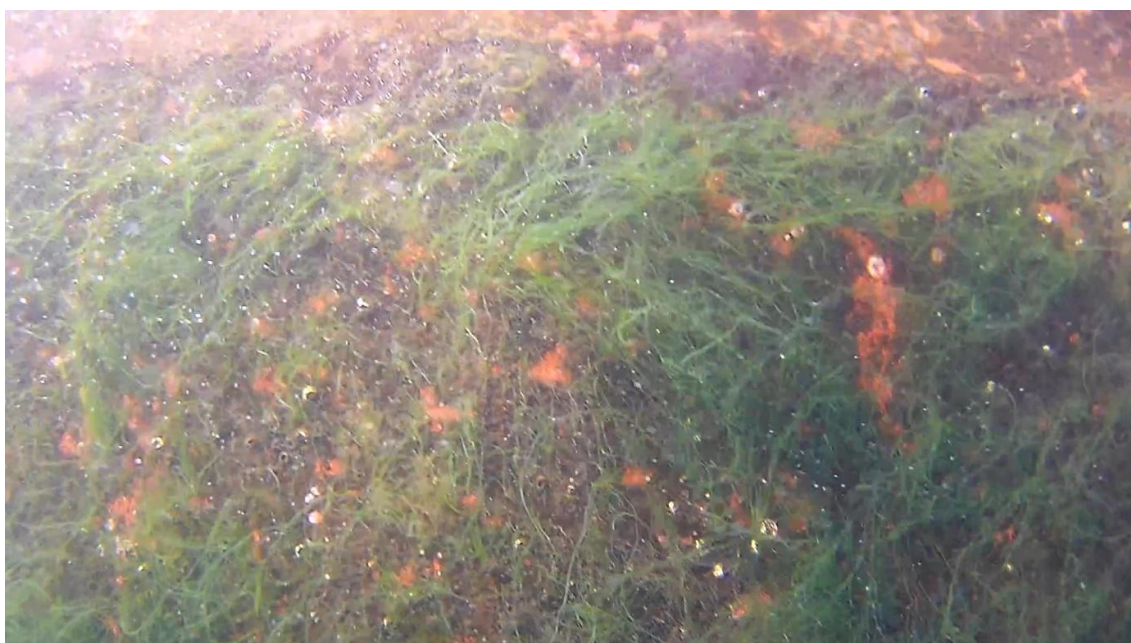
Fig. 16: Cleanable hard coating of Jotun, 'Wega', April 2019 with heavy macrofouling mainly composed of filamentous algae and barnacles, before cleaning, Wega diving crew

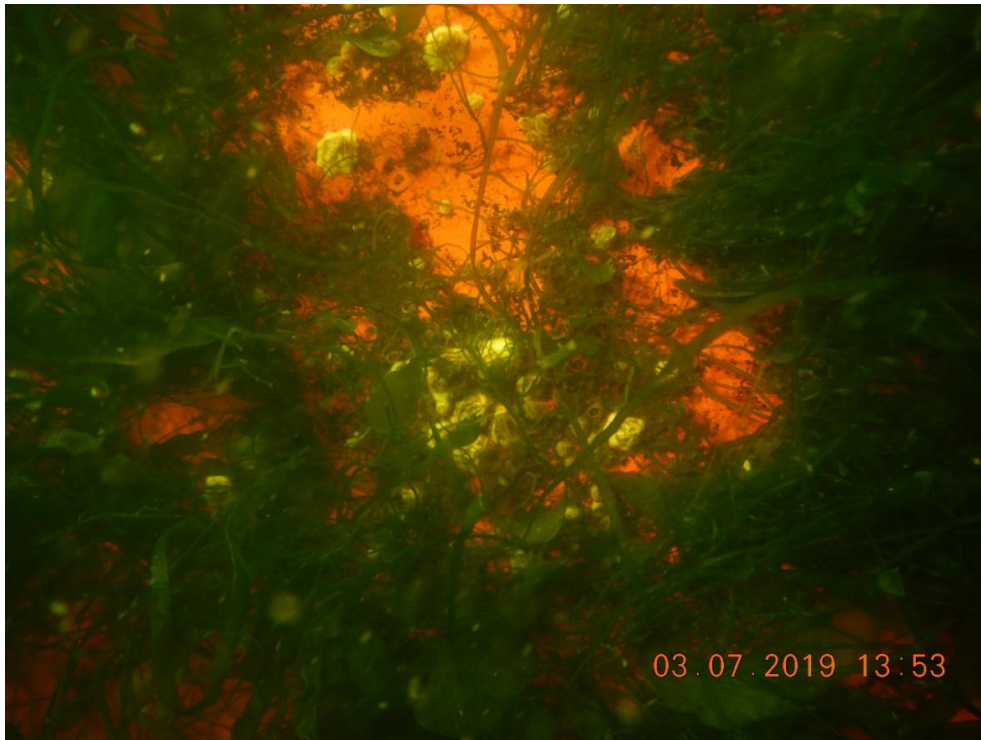
Fig. 17: Cleanable hard coating of Jotun, 'Wega', April 2019 with heavy macrofouling mainly composed of filamentous algae and barnacles, before cleaning, DG Diving

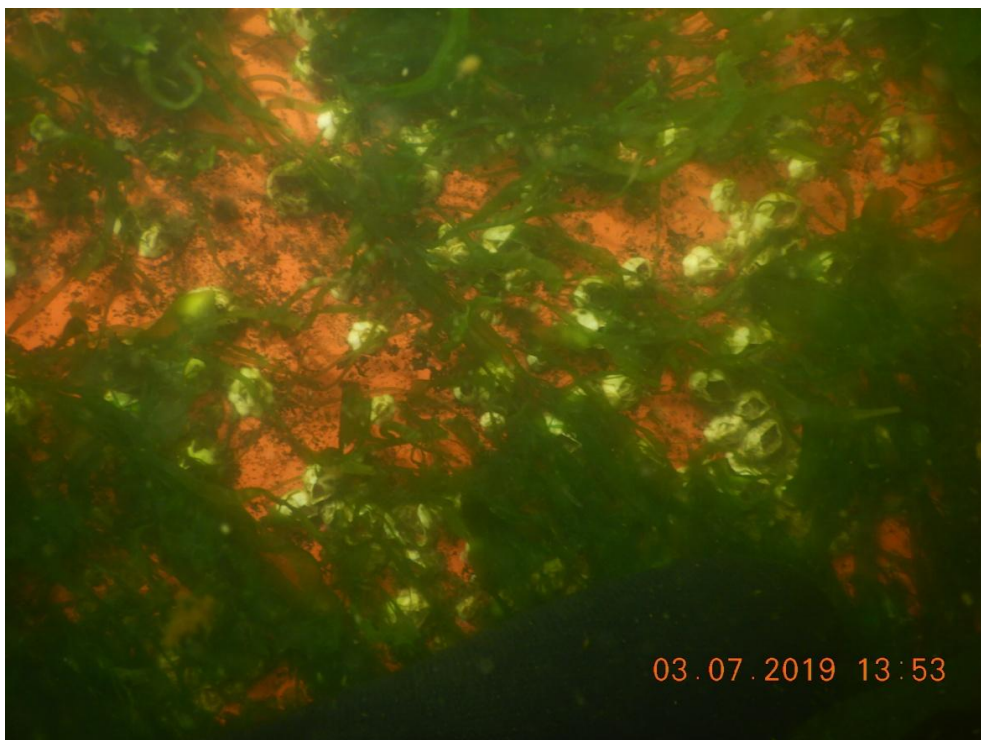
Fig. 18: Cleanable hard coating of Jotun, 'Wega', July 2019 with heavy macrofouling mainly composed of filamentous algae and barnacles, before cleaning, DG Diving

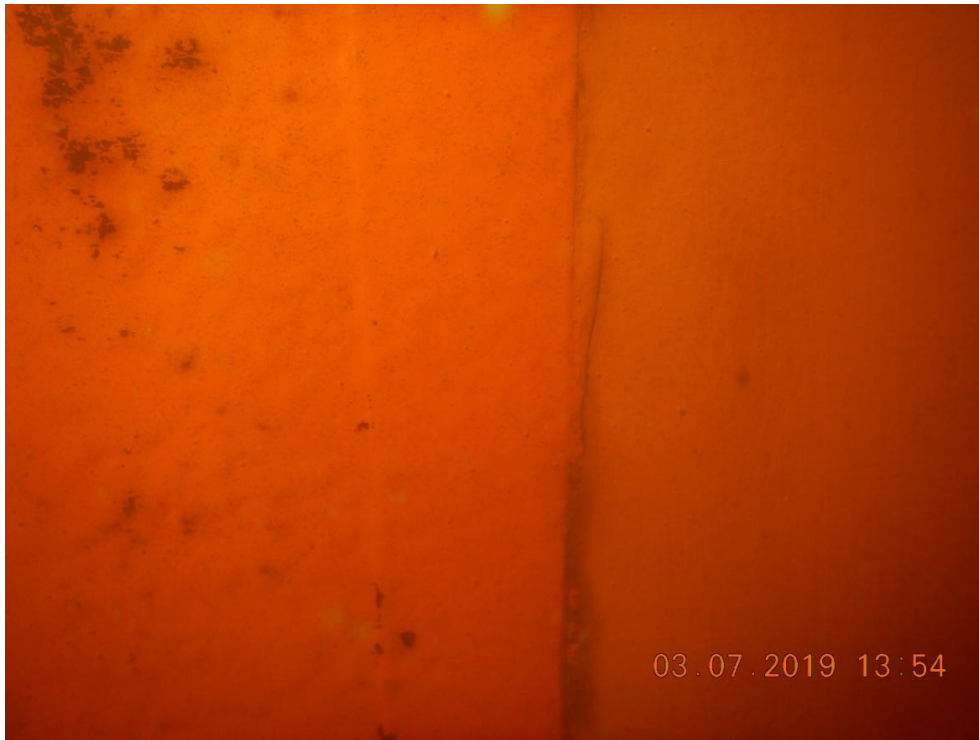
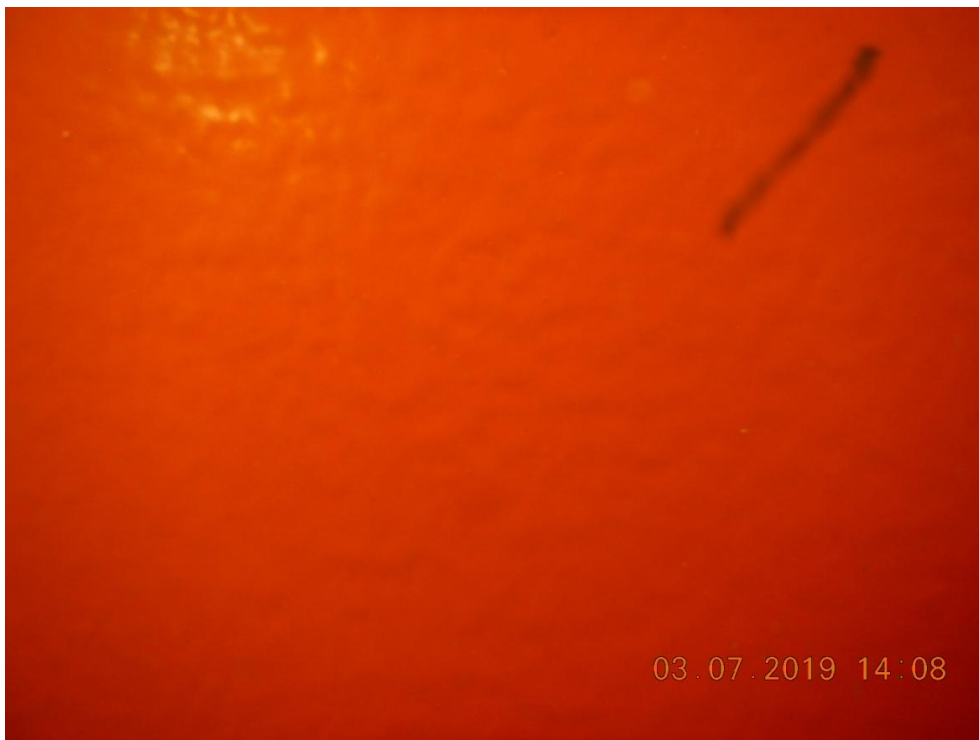
Fig. 19: Cleanable hard coating of Jotun, ,Wega', July 2019 with heavy macrofouling mainly composed of filamentous algae and barnacles, after cleaning DG Diving

Fig. 20: Cleanable hard coating of Jotun, ,Wega', July 2019 with heavy macrofouling mainly composed of filamentous algae and barnacles, after cleaning, DG Diving

As can be perceived by the images, the fouling had completely been removed without damaging the coating. In addition, the cleaning with hp water in the dry dock revealed the previous complete removal of fouling and displayed an intact coating (Fig. 21).

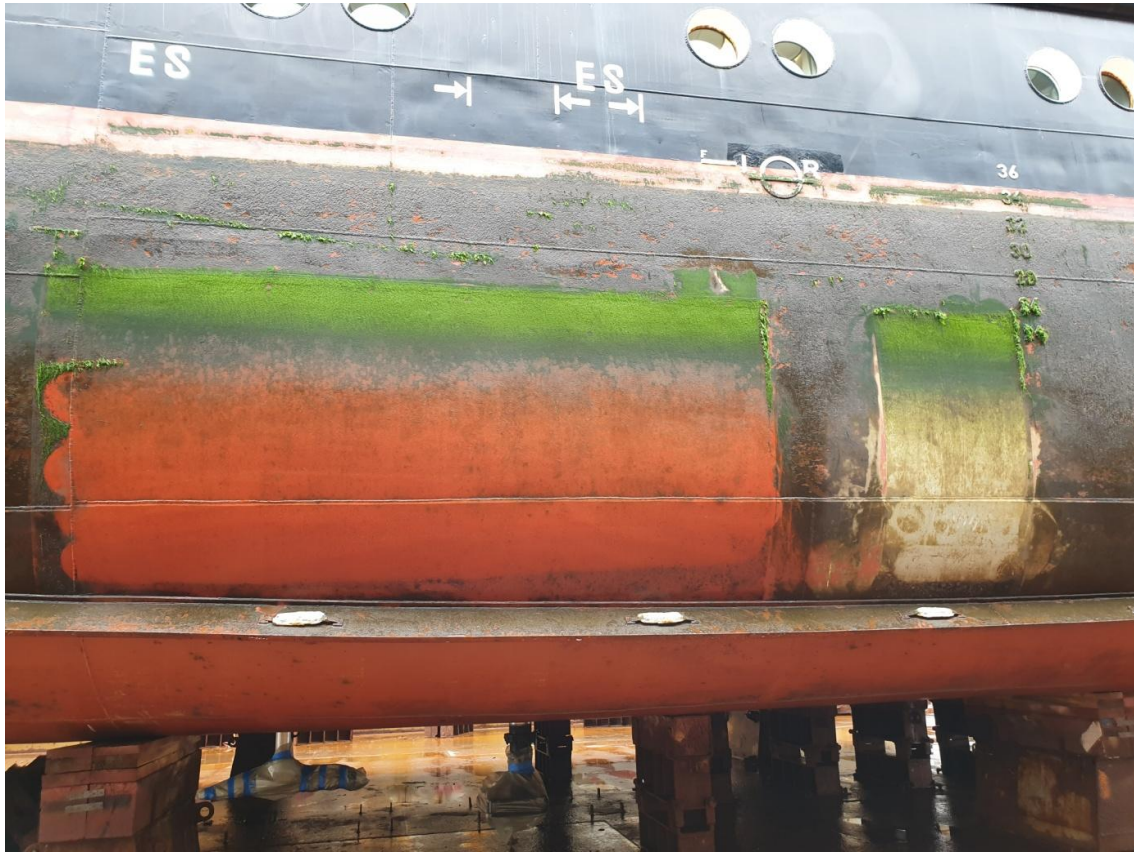
Fig. 21: Cleanable hard coatings, portside ‚Wega‘, test patches left Jotun, right Momentive/Wohlert, July 2019

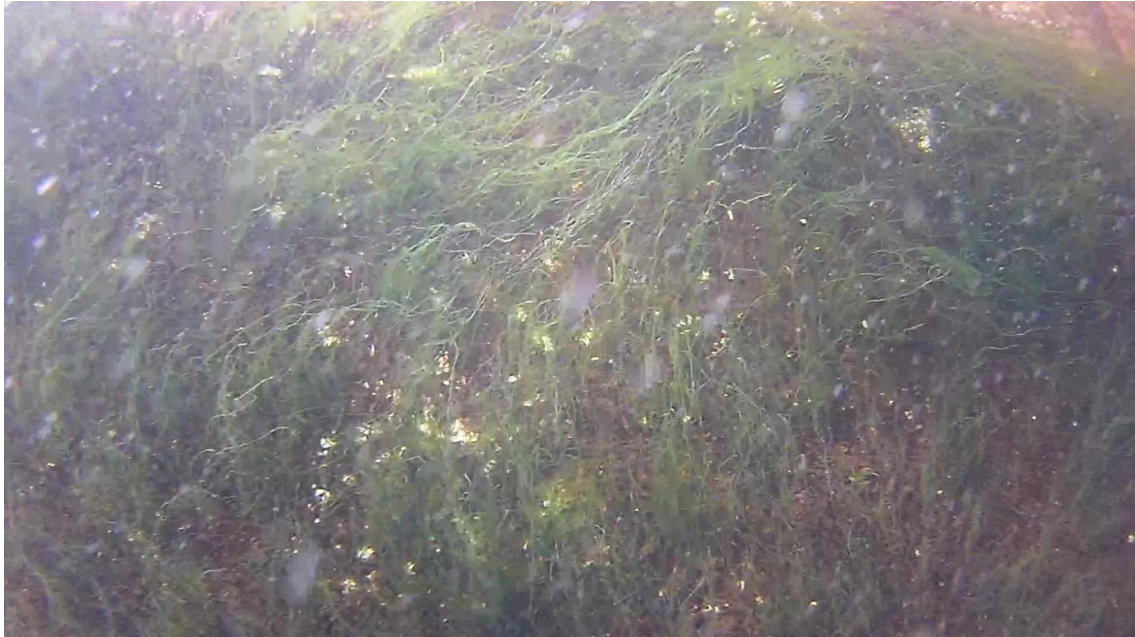
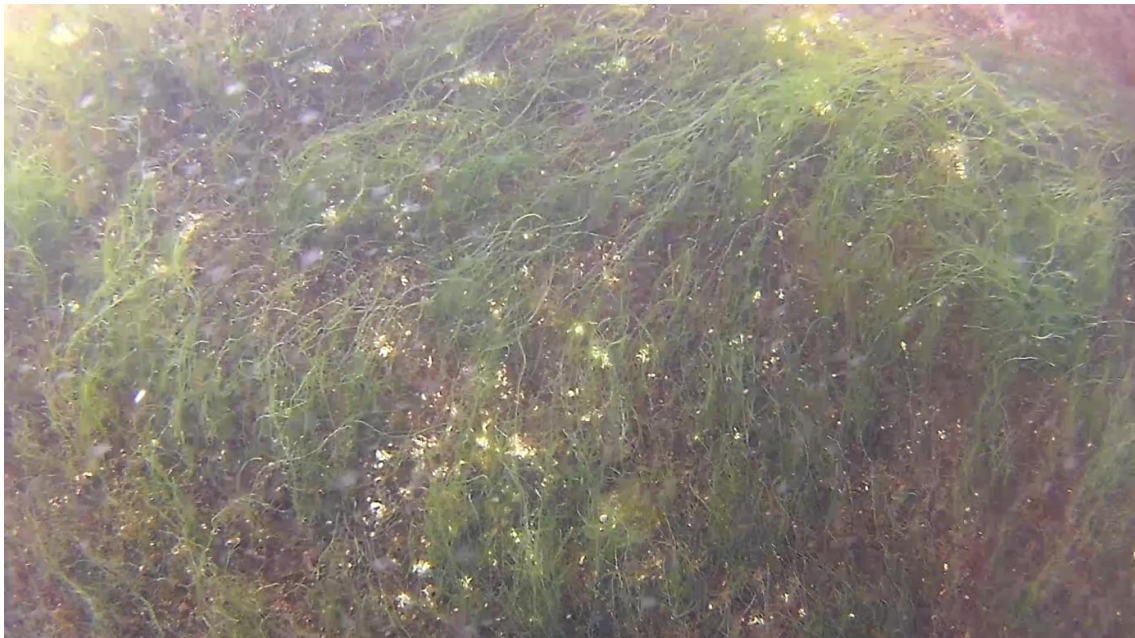
Heavy fouling mainly composed of filamentous algae and barnacles was present after two years on the coating of Momentive/Wohlert without cleaning (Fig. 22 and 23). In July 2019, before cleaning a comparable fouling community as on the Jotun coating was visible (Fig. 24 and 25). But on this coating the fouling could be removed completely with any damage to the coating (Fig. 26). The latter could be proofed after hp-washing in the dock (Fig. 27).

Fig. 22: Cleanable hard coating of Momentive/Wohlert, ‚Wega‘, April 2019, with filamentous algae and barnacles, before cleaning, Wega‘ Diving crew

Fig. 23: Cleanable hard coating of Momentive/Wohlert, ‚Wega‘, April 2019, with filamentous algae and barnacles, before cleaning, ‚Wega‘ Diving crew

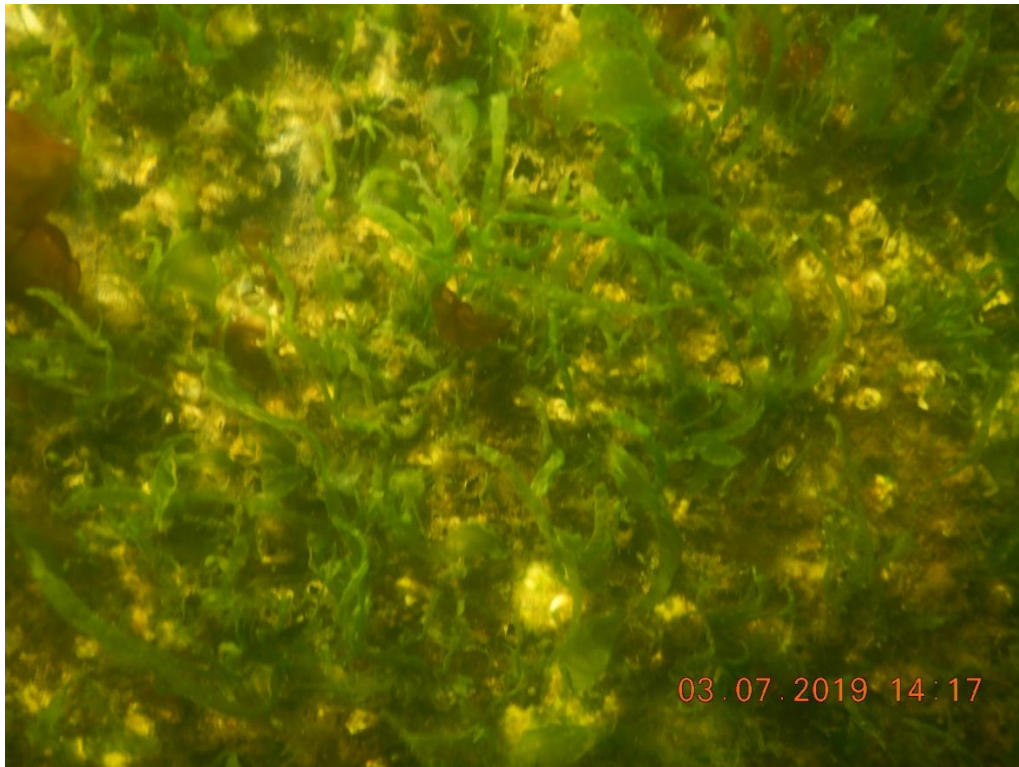
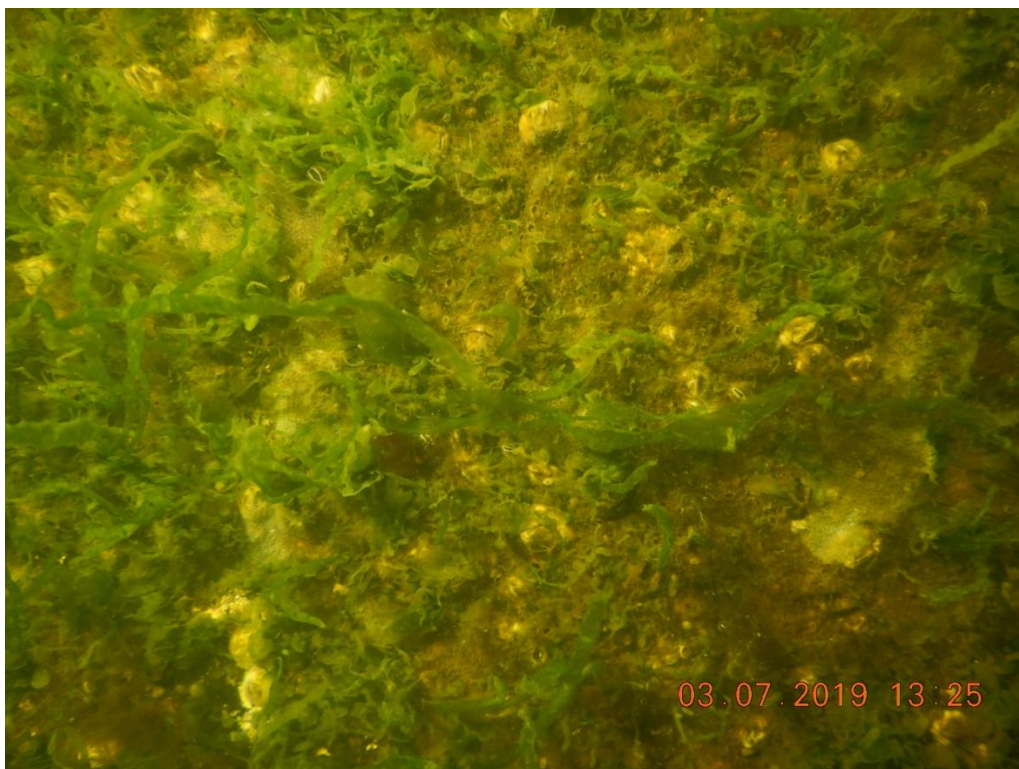
Fig. 24: Cleanable hard coating of Momentive/Wohlert, ‚Wega‘, July 2019, with filamentous algae and barnacles, before cleaning, DG Diving

Fig. 25: Cleanable hard coating of Momentive/Wohlert, ‚Wega‘, July 2019, with filamentous algae and barnacles, before cleaning, DG Diving

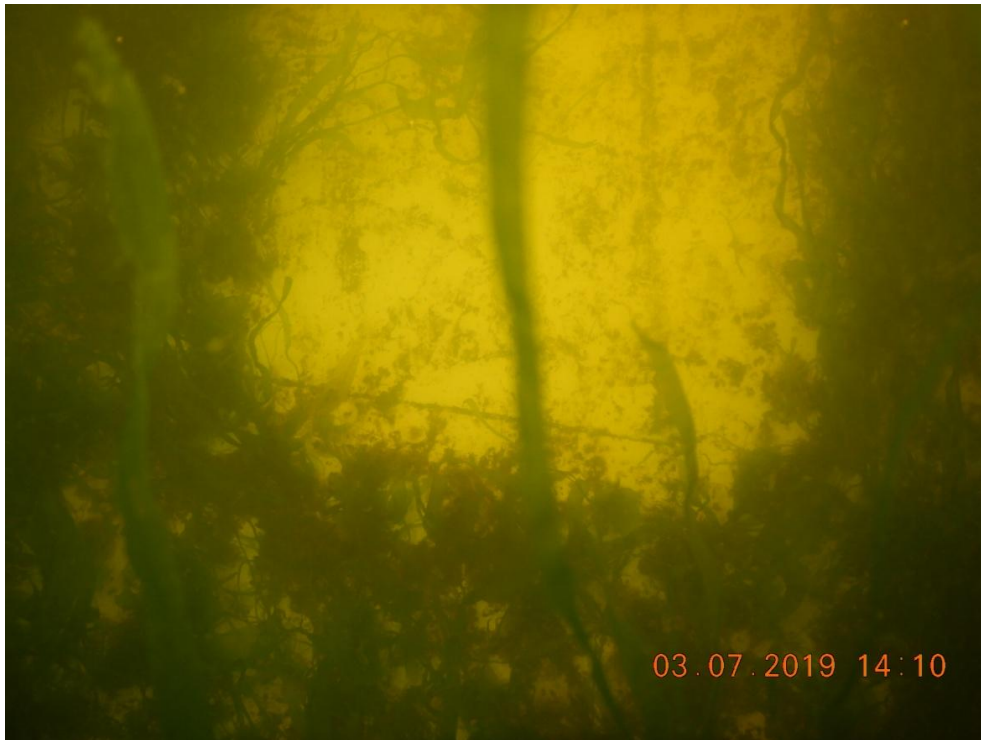
Fig. 26: Cleanable hard coating of Momentive/Wohlert, 'Wega', July 2019, with filamentous algae and barnacles, partly cleaned, DG Diving

The cleaning could be effected successfully at the lower areas of the coating. Efficacy of cleaning could be verified in the dry dock (Fig. 27), and the undamaged condition of the coating was revealed after hp water washing.

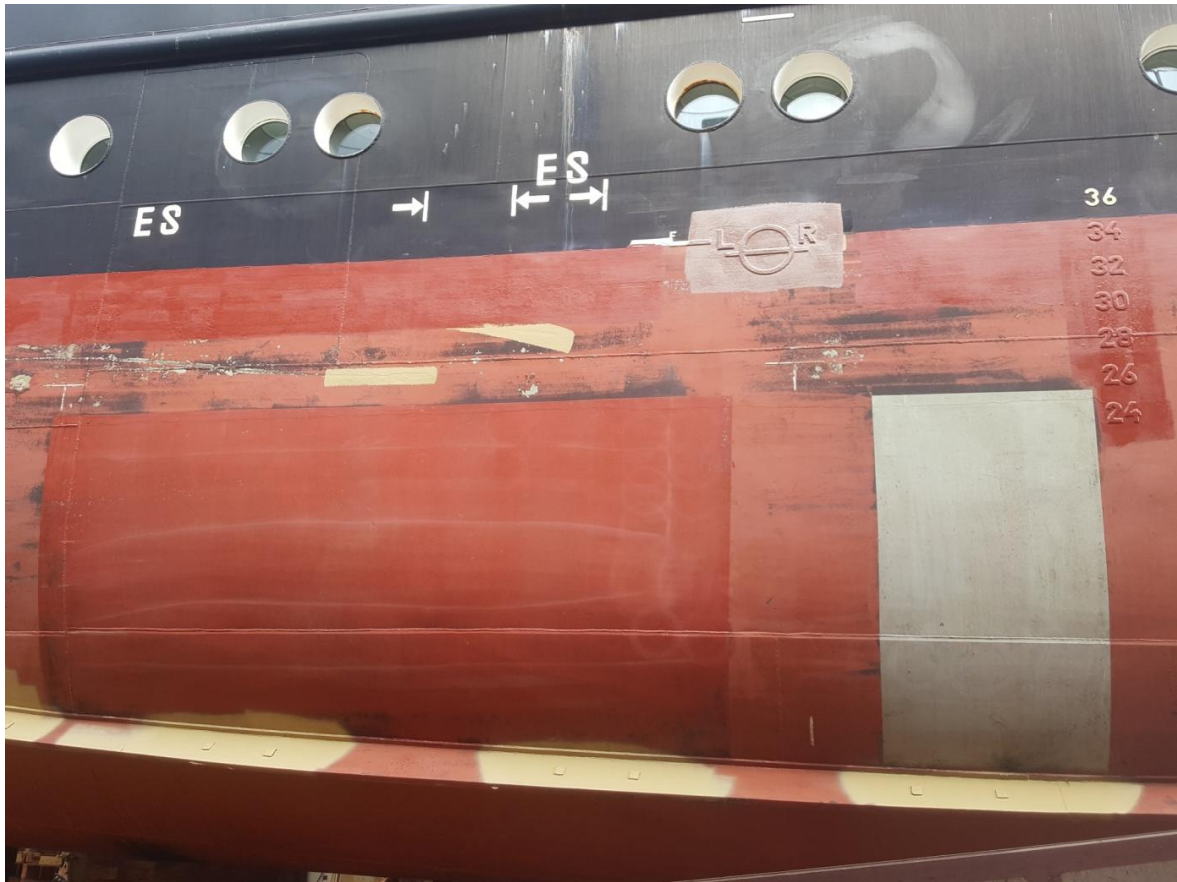
Fig. 27: Cleanable hard coatings, portside, 'Wega', after hp washing in the dry dock, July 2019, left Jotun, right Momenitive/Wohlert

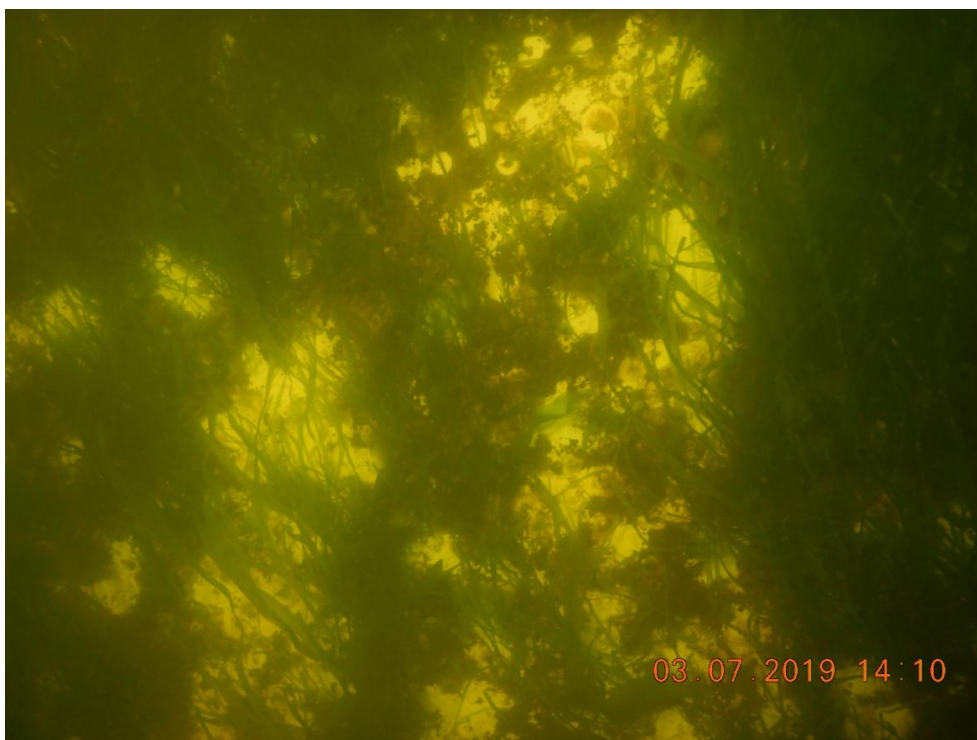
Fig. 29: Foul release coating of Momenitive, starboard, 'Wega', covered by filamentous algae and barnacles, July 2019, before cleaning, DG Diving

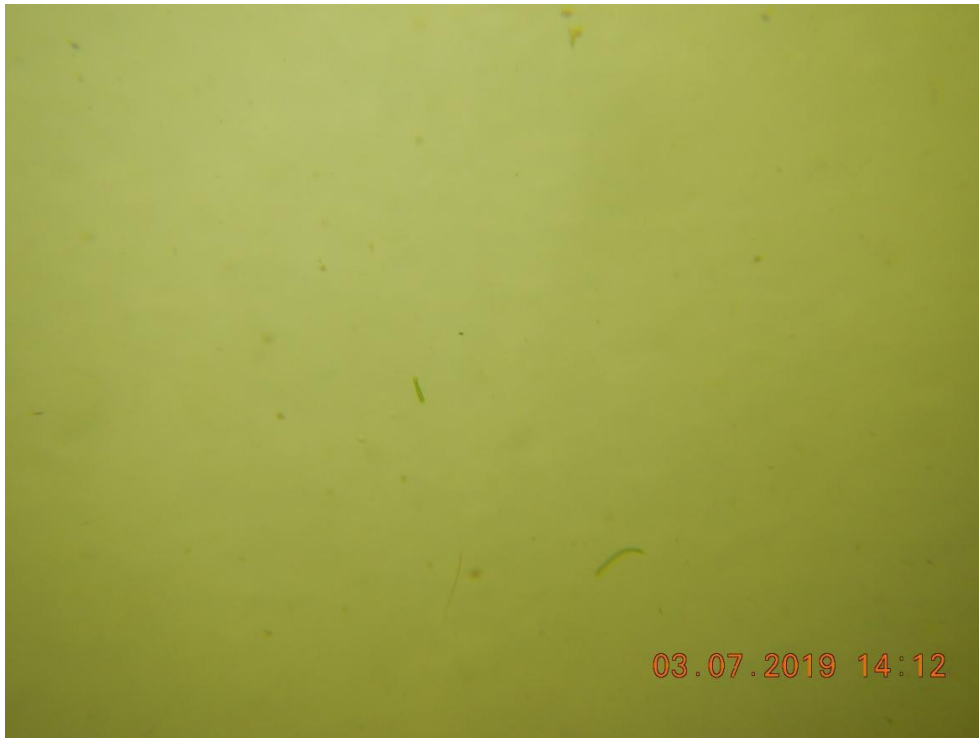
Fig. 30: Foul release coating of Momenitive, ,Wega', July 2019, lower part after cleaning, DG Diving

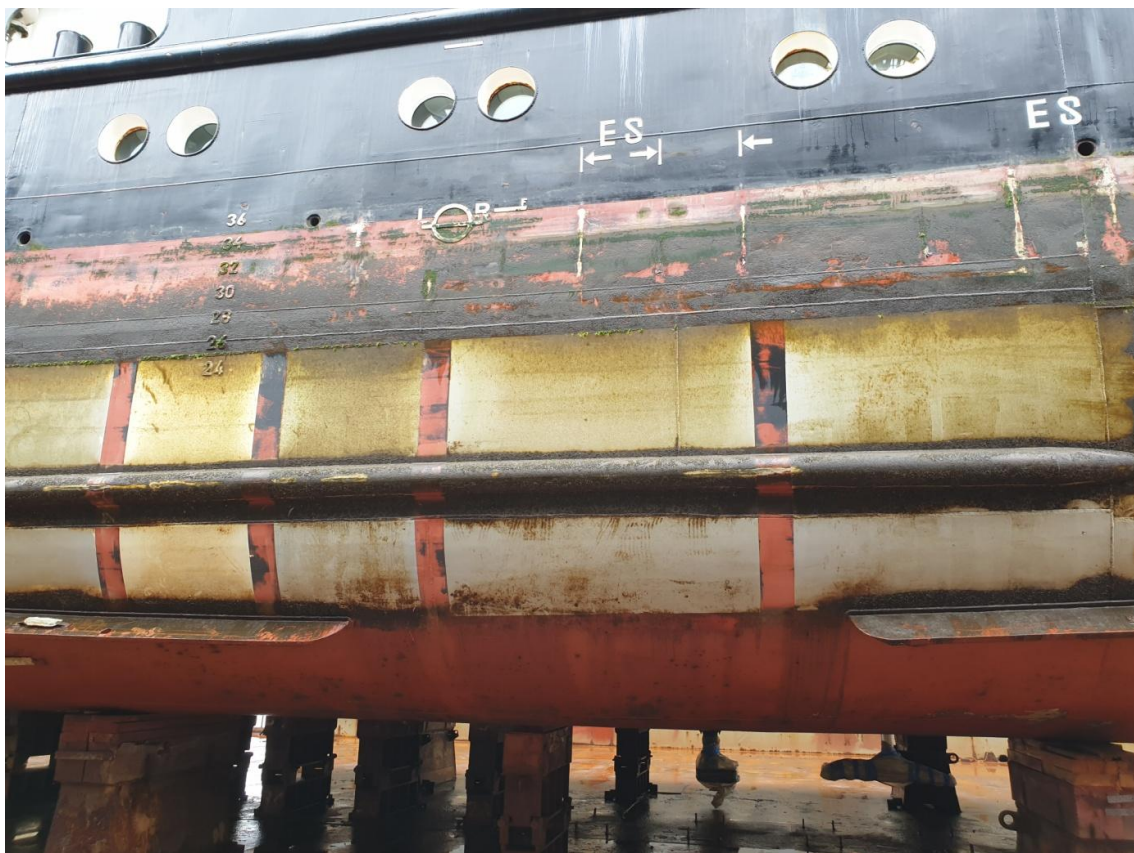
Fig. 31: Test patches of foul release coatings, ,Wega', July 2019, after underwater cleaning

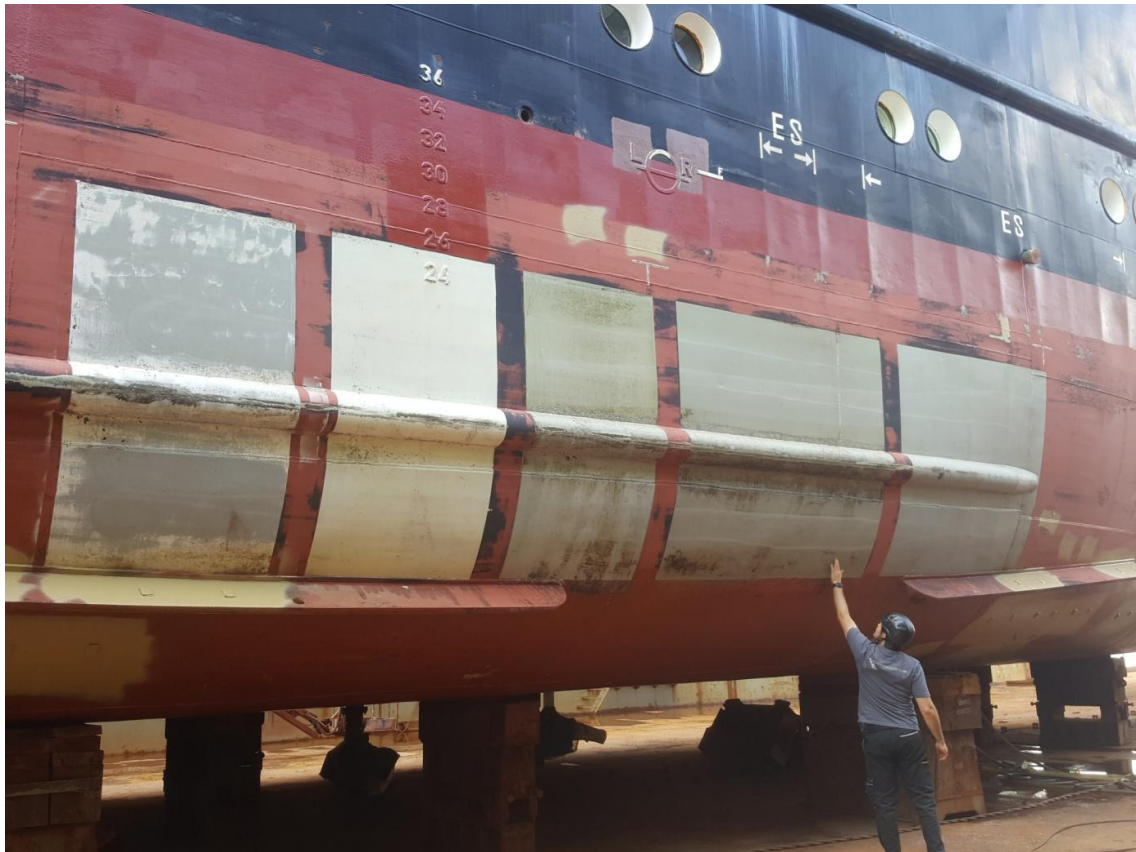
During the research project FOULPROTECT, additional test patches had been applied in November 2015 on starboard (Fig. 28). These coatings should possess self cleaning respective foul release properties. Most of them displayed insufficient non-stick properties, and had been cleaned at dry docking in March 2017. In July they displayed heavy fouling (Fig. 29, e.g. Momenitive), and were cleaned as well along the lower areas of each coating (Fig. 30, e.g. Momenitive). All coatings were cleaned without remaining fouling (Fig. 31). During the hp-washing in the dry dock it turned that some of these coatings were too soft for cleaning impact, and the upper layers had been removed (Fig. 32).

Fig. 32: Test patches of foul release coatings, ,Wega', July 2019, after hp-washing in dry dock

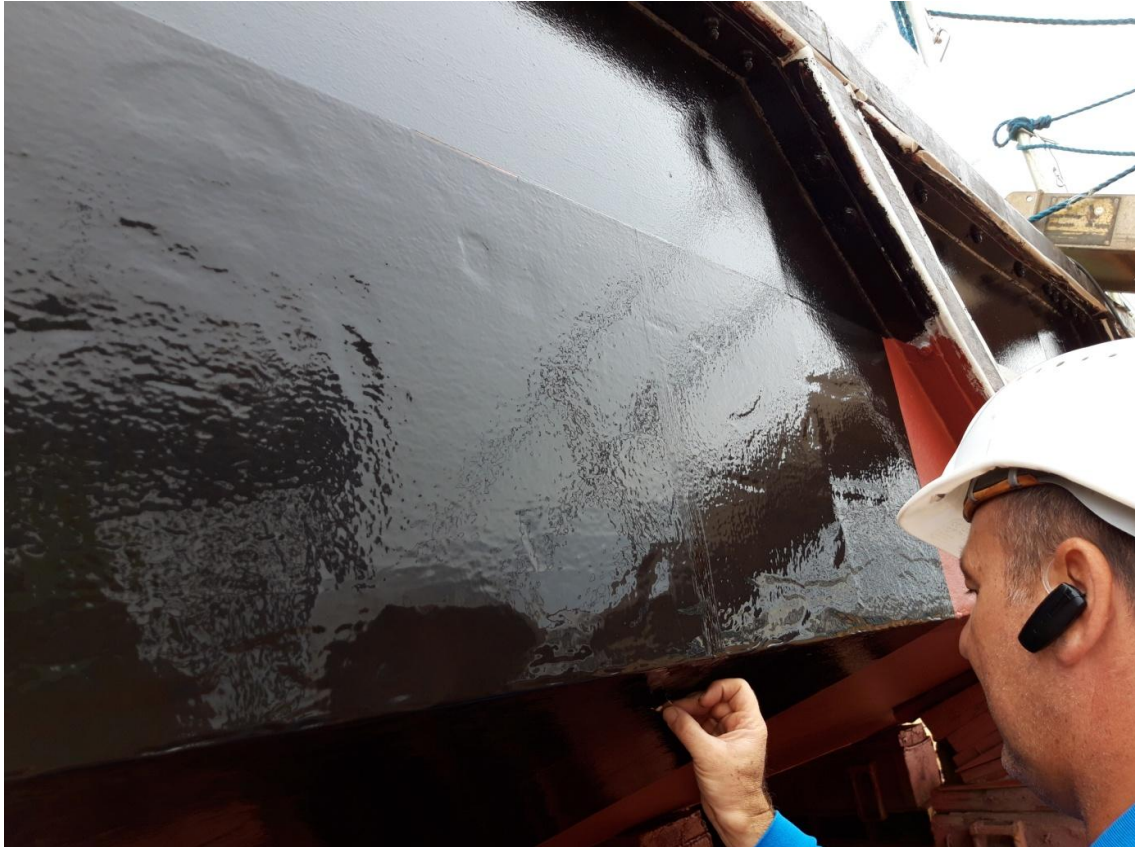
Fig. 40: Foul release adhesive film ,Dolphin S', mis ships ,MÖWE' during application August 2019

Unfortunately, the film was mechanically damaged so severely that it partially peeled off and had to be removed in 2020.
