Interim-Report CLEAN, Version May 2021

In-water Cleaning Trials and Permission Requirements

B. Watermann, LimnoMar, Hamburg,
Donna Lee Garrick, Die Senatorin für Klimaschutz, Umwelt, Mobilität,
Stadtentwicklung und Wohnungsbau Bremen,
Katja Pape, bremenports

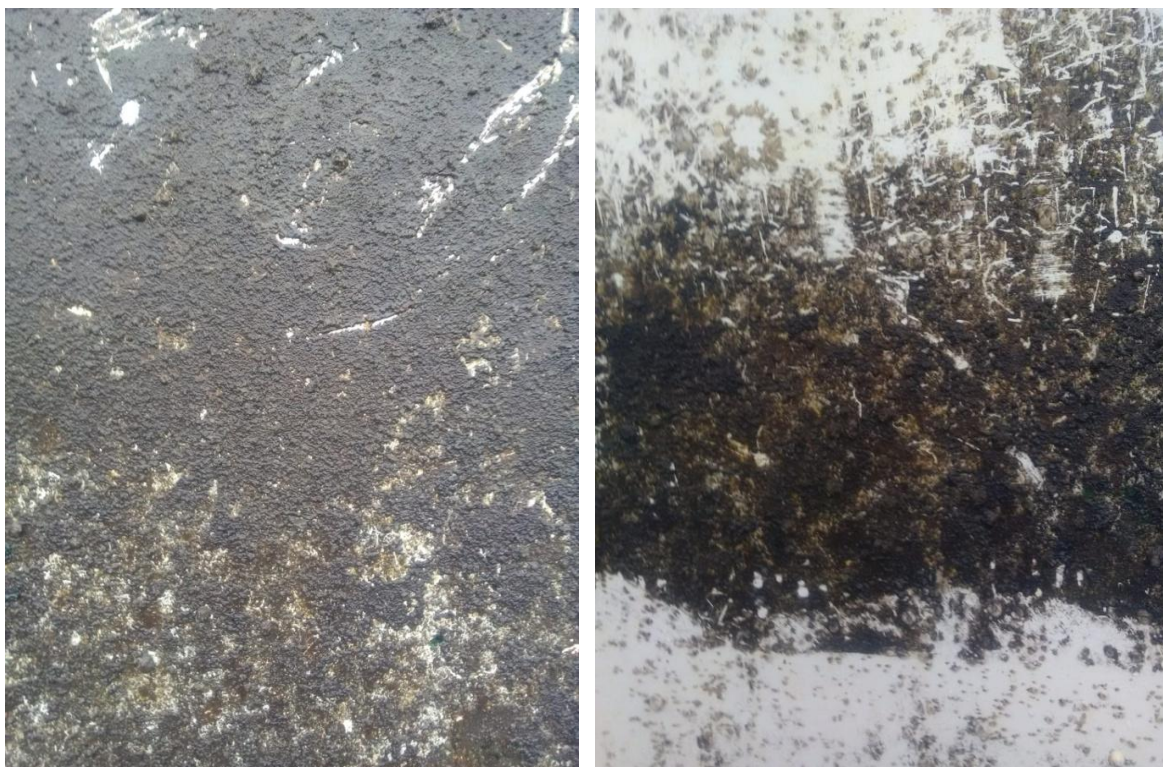
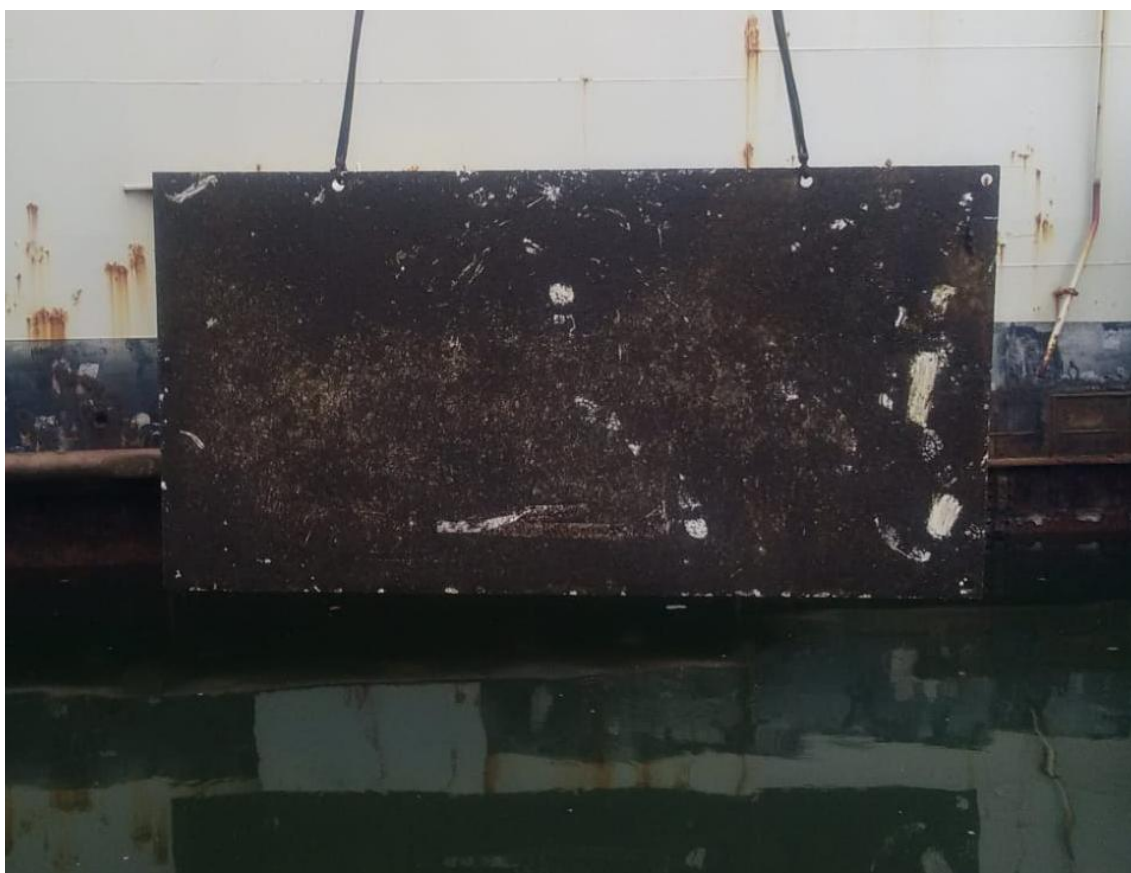
November 2019 after 7 months of exposure, the cleaning robot KeelCrab was tested (Fig. 43). The fouling community on the steel panel was composed of smaller and larger barnacles with base plate diameters of 3 - 4 and 5 – 7 mm respectively, to a minor degree tunicates, hydrozoa and short filamentous algae were present. The fouling coverage was estimated as 15% (Fig. 44 and 45).

Fig. 44: Fouling on steel panel after 7 months of static exposure Bredo-Dockyards, Bremerhaven

Fig. 45: Steel panel after 7 months of static exposure, before cleaning

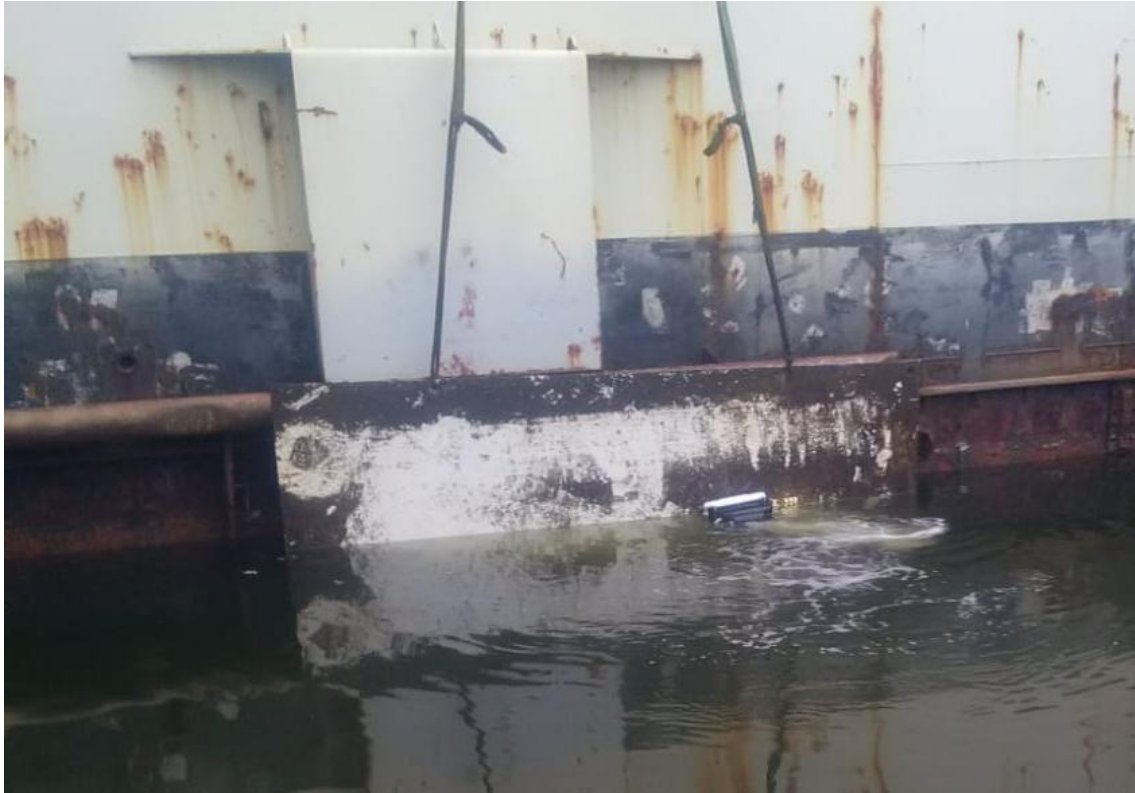
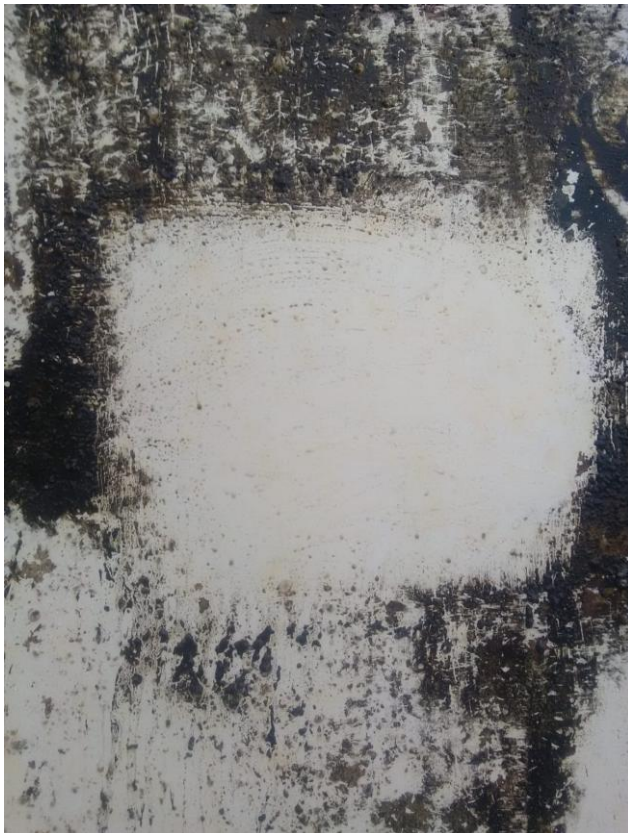
Fig. 46: KeelCrab in action on the steel panel, November 2019

Fig. 47: Close-up of cleaned area of steel panel, November 2019

KeelCrab cleaned effectively the painted surface. Apart of some larger barnacles the fouling could be removed (Fig. 46 and 47). The condition of the paint was undamaged and possessed its hydrophobic surface even after cleaning.
