Interim-Report CLEAN, Version May 2021

In-water Cleaning Trials and Permission Requirements

B. Watermann, LimnoMar, Hamburg,
Donna Lee Garrick, Die Senatorin für Klimaschutz, Umwelt, Mobilität,
Stadtentwicklung und Wohnungsbau Bremen,
Katja Pape, bremenports

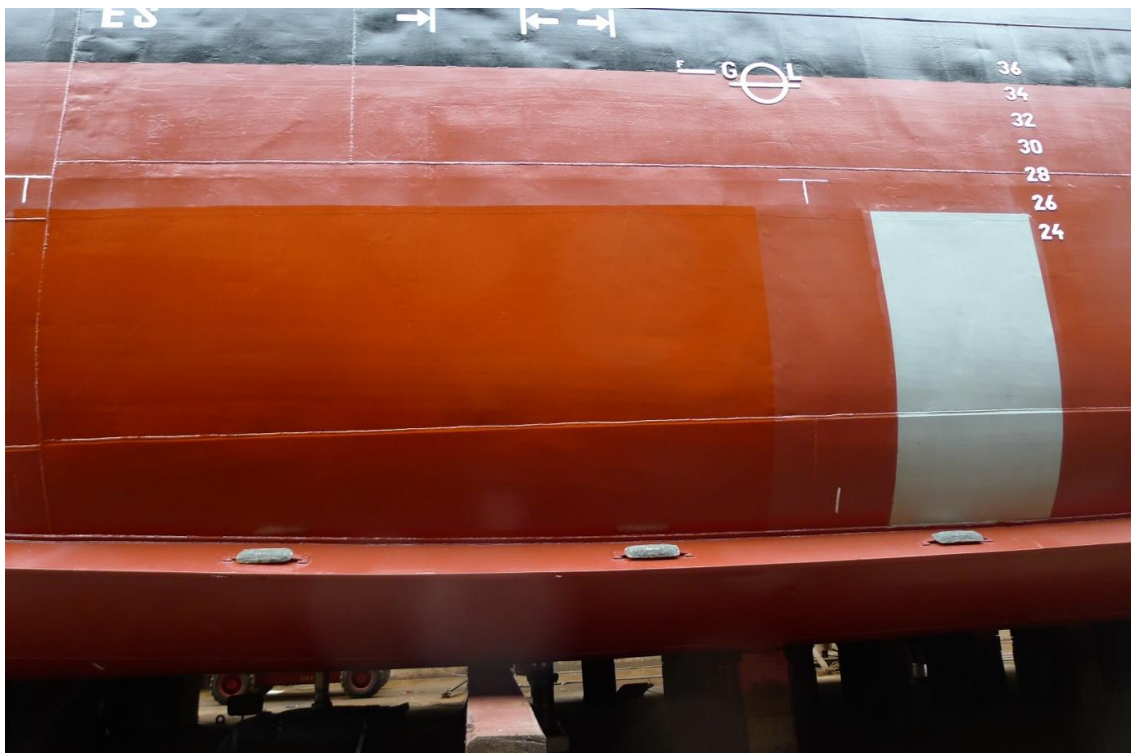
Fig. 15: Cleanable hard coatings, portside 'WEGA', after application, November 2015

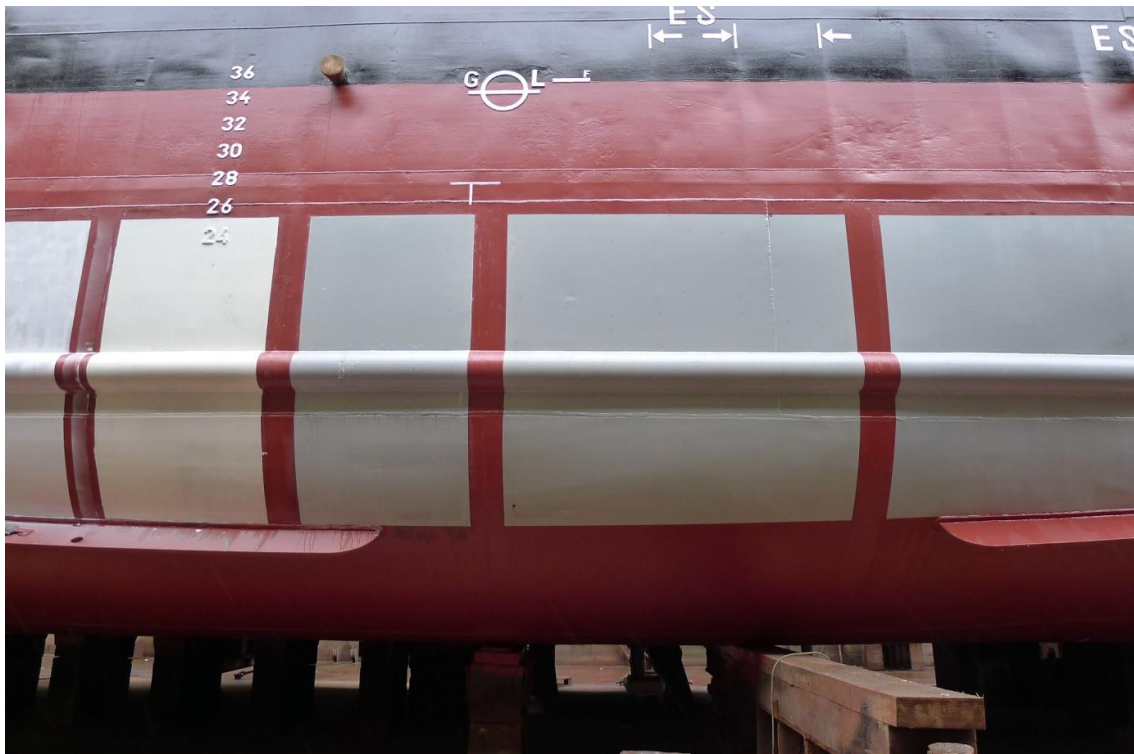
During the research project FOULPROTECT, additional test patches had been applied in November 2015 on starboard (Fig. 28). These coatings should possess self cleaning respective foul release properties. Most of them displayed insufficient non-stick properties, and had been cleaned at dry docking in March 2017. In July they displayed heavy fouling (Fig. 29, e.g. Momenitive), and were cleaned as well along the lower areas of each coating (Fig. 30, e.g. Momenitive). All coatings were cleaned without remaining fouling (Fig. 31). During the hp-washing in the dry dock it turned that some of these coatings were too soft for cleaning impact, and the upper layers had been removed (Fig. 32).

Fig. 28: Foul release coatings on starboard after application November 2015, 'Wega'

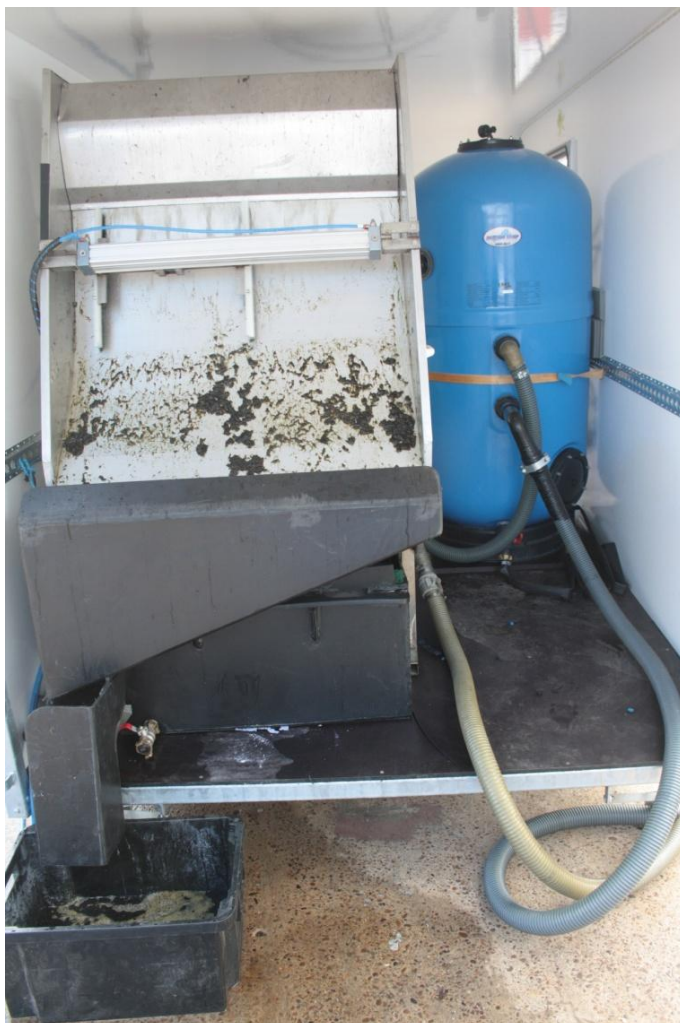
The underwater cleaning machine of DG Diving is connected to water treatment system with a two-step filtration unit equipped with thief and fleece filter (see Report DG Diving 2019; HELCOM, 2015). This unit is able to separate biofouling organisms from the cleaning process water and also remove nutrients, phosphorus and nitrogen, from cleaning process water down to 100 µm. All solid waste can be collected and handled in a proper way on shore (Fig. 33).

Fig. 33: Water treatment unit with thief filter (100 µm pore size) above a fleece filter (100 µm pore size) with grey tube releasing the treated water back into the harbour basin.

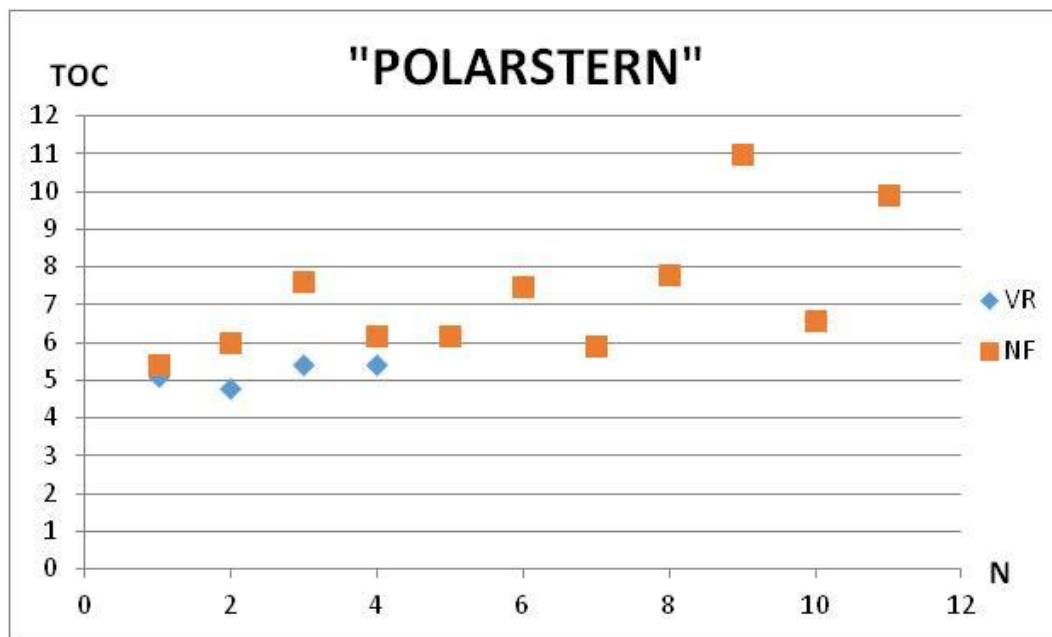
The TOC mean value of the harbour water taken at berth of 'POLARSTERN' in the harbour before cleaning was determined as 5.2 mg/l and after filtration as 7.3 mg/l (tab. 2 und fig. 35).

Fig. 35: TOC-values water samples of the transatlantic port, Bremerhaven, before underwater cleaning (VR) and during underwater cleaning of the hull of 'POLARSTERN', after filtration (NF)

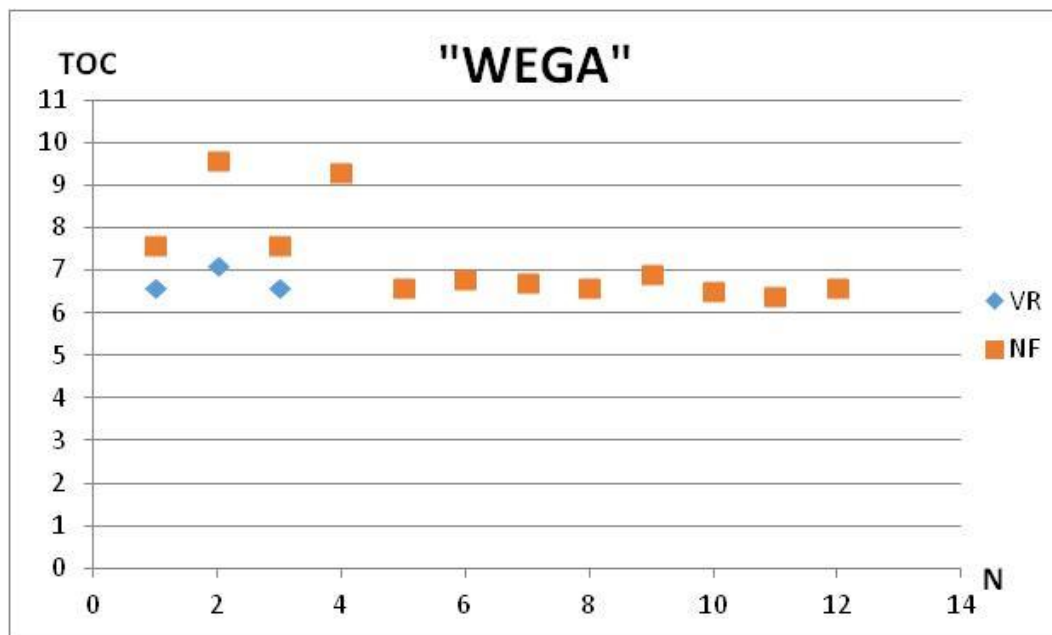
TOC-mean values before cleaning the hull of 'WEGA' at berth in the fishery harbour, Bremerhaven were 6.8 mg/l and during the cleaning action 7.3 (tab. 3 und fig. 36).

Fig. 36: TOC-values of harbour water, Bremerhaven, Fischereihafen before cleaning (VR) and during cleaning of the hull of 'WEGA', collected after filtration (NF)

TOC-values during cleaning were slightly elevated. The mean values were identical albeit the fouling community on 'WEGA' was much developed.

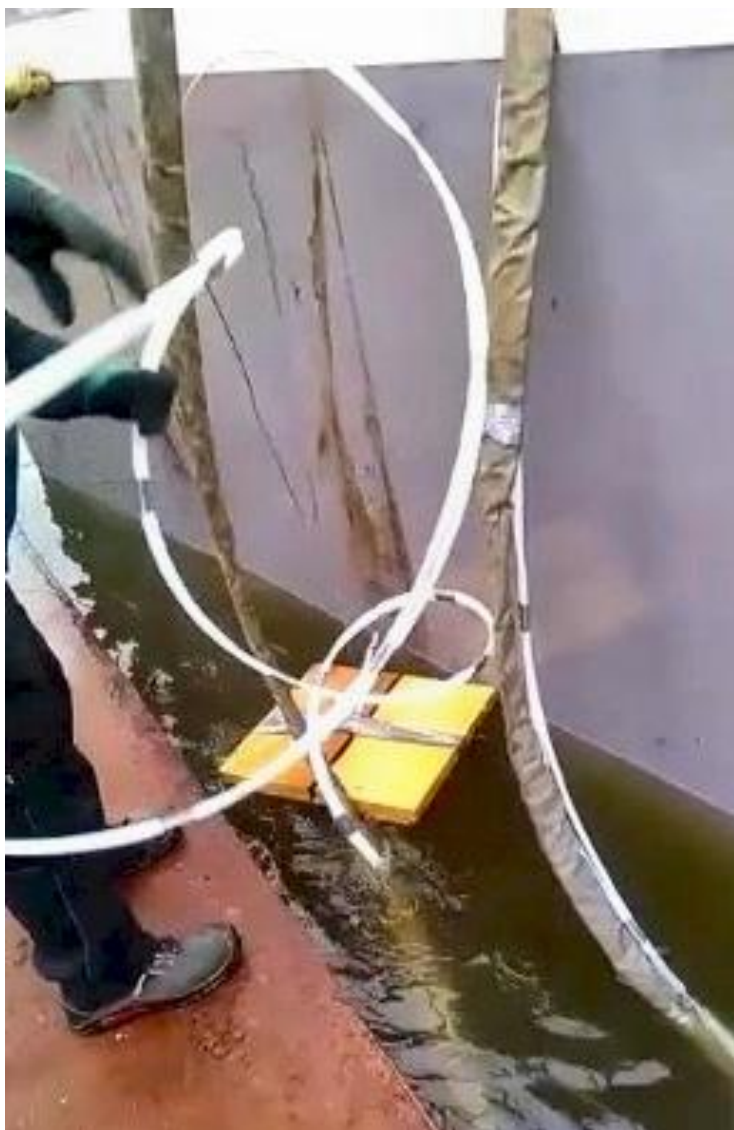
For cleaning trials with direct control of efficacy a steel panel was coated with the hard coating Overdrive and statically exposed at Bredo Dockyards, Bremerhaven. The panel is totally submerged but can be lifted above the water on demand (Fig. 42). The steel panel served as test area for smaller cleaning robots.

Fig. 42: Steel panel BREDO Dockyards, for cleaning trials with cleaning trials

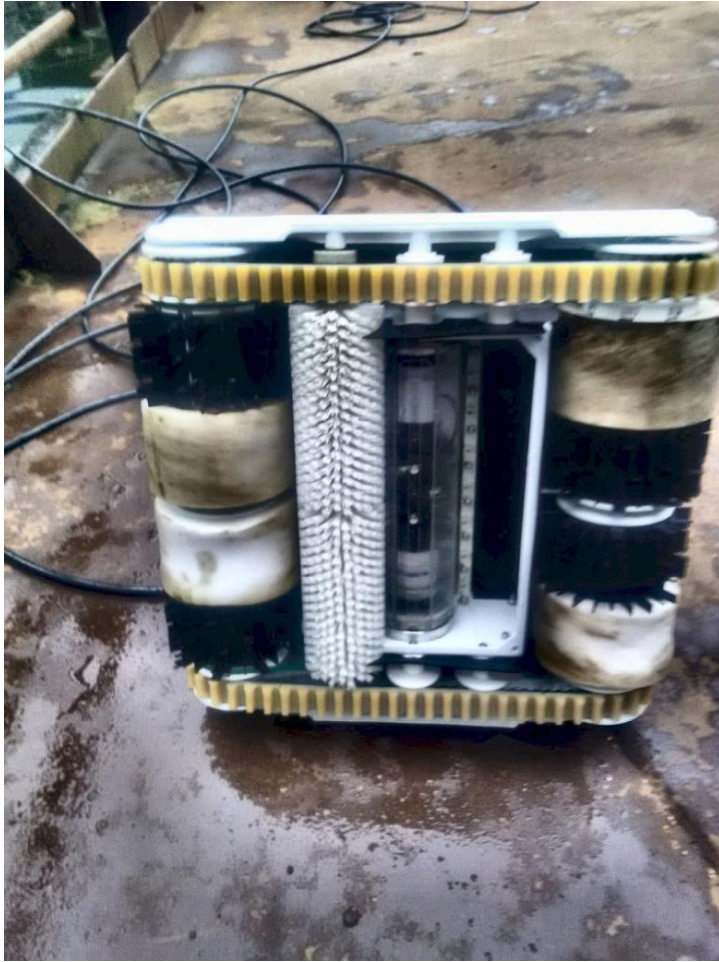
November 2019 after 7 months of exposure, the cleaning robot KeelCrab was tested (Fig. 43). The fouling community on the steel panel was composed of smaller and larger barnacles with base plate diameters of 3 - 4 and 5 – 7 mm respectively, to a minor degree tunicates, hydrozoa and short filamentous algae were present. The fouling coverage was estimated as 15% (Fig. 44 and 45).

Fig. 43: KeelCrab cleaning robot
